Appleton Public Library

council meeting

existing conditions | Appleton Public Library

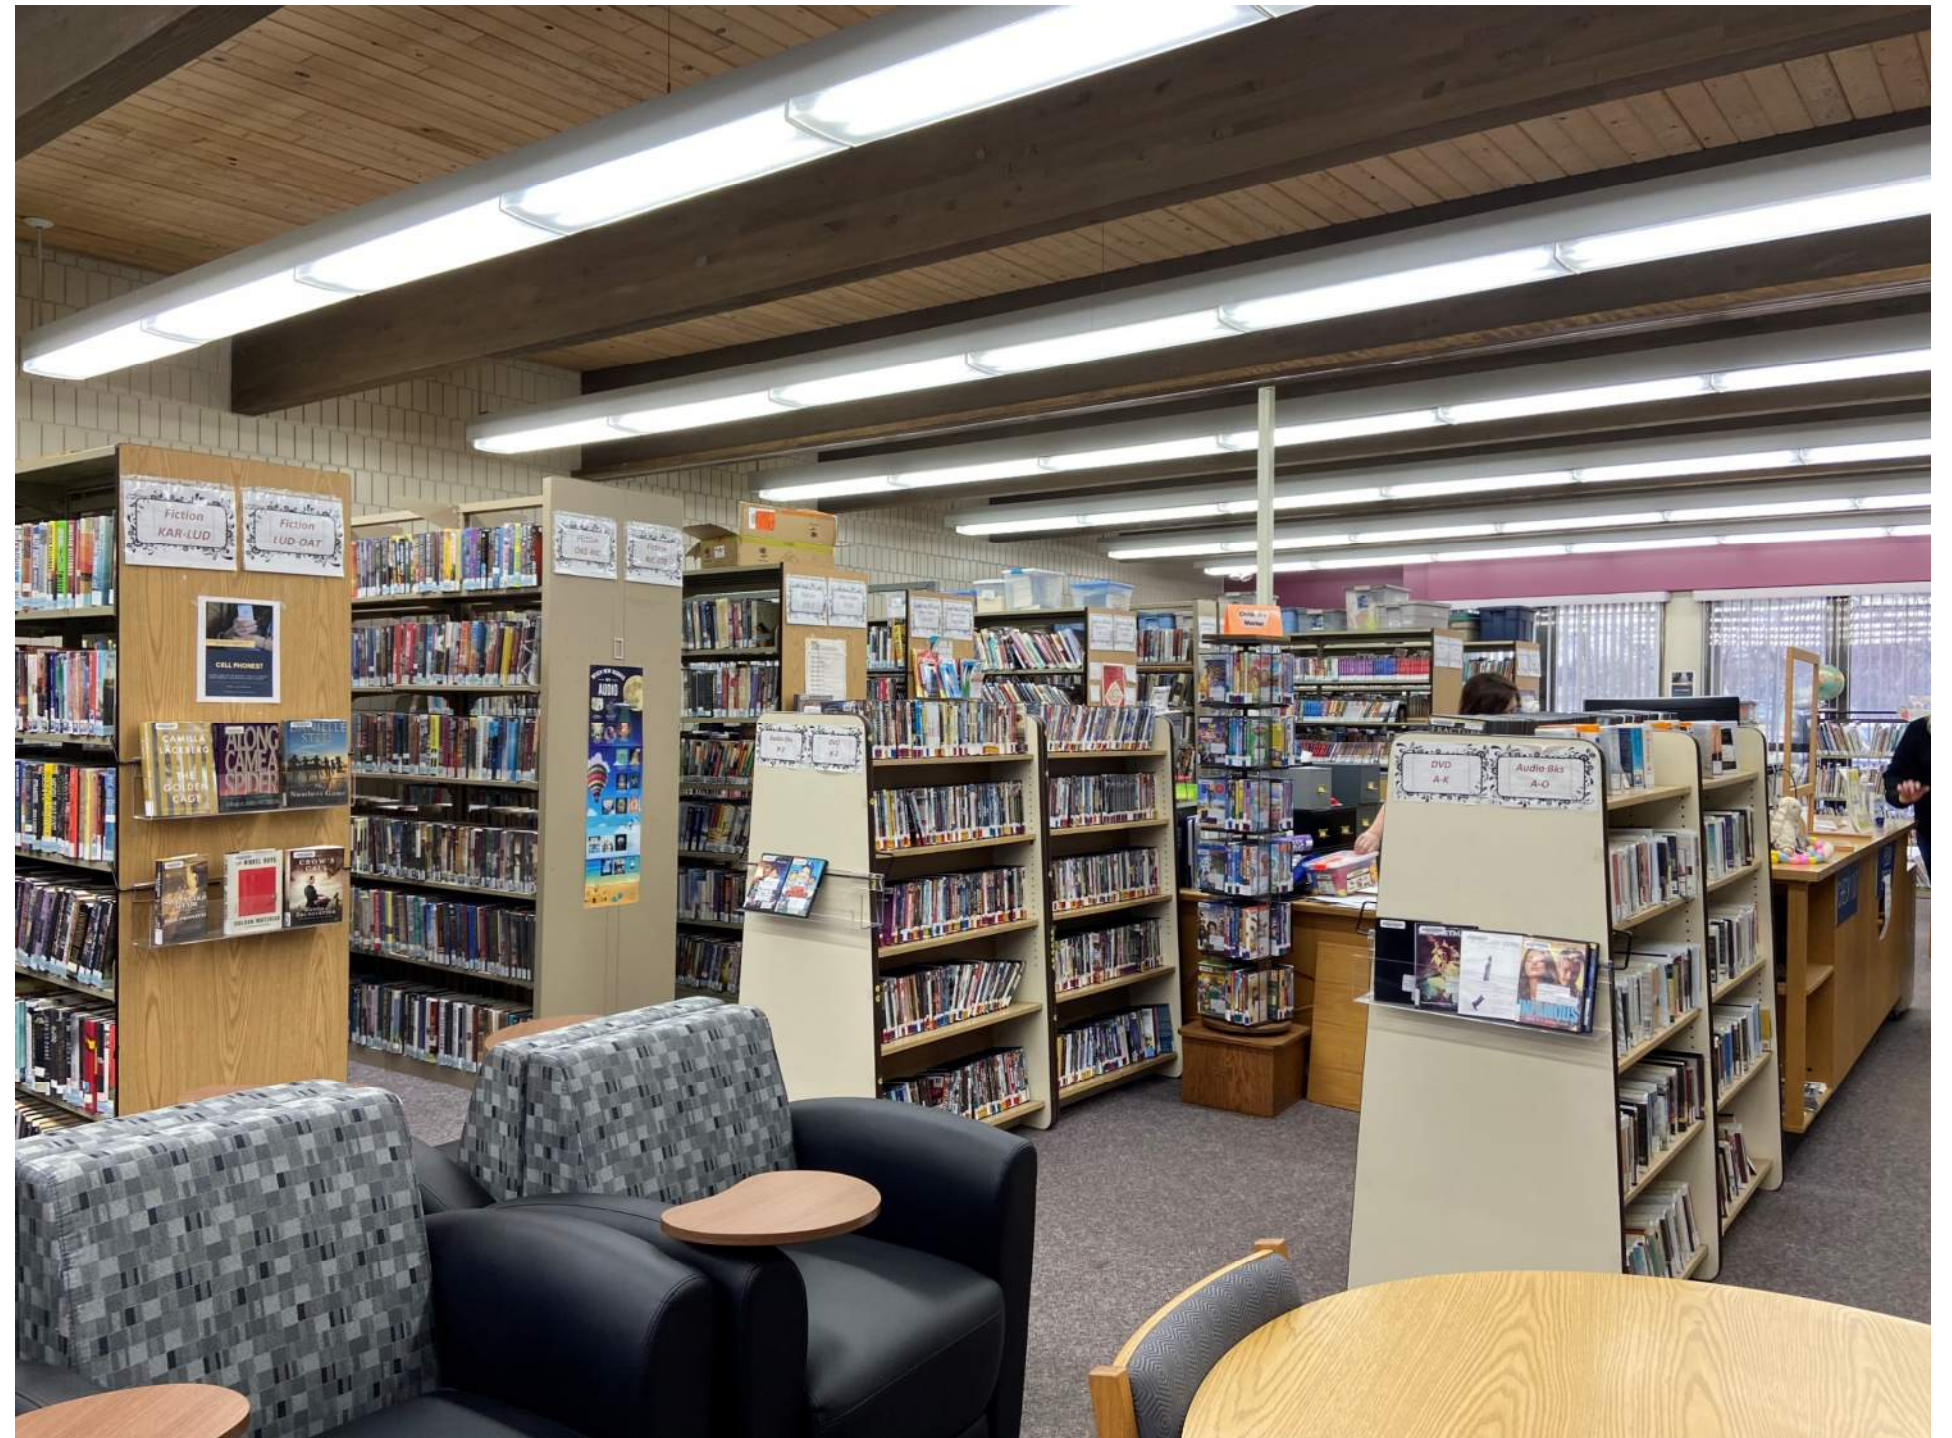
- Aisles too narrow to comply with ADA requirements
- No meeting room
- Many items stored too high to be reachable by patrons
- No space for increased collection

View of seating and adult collection

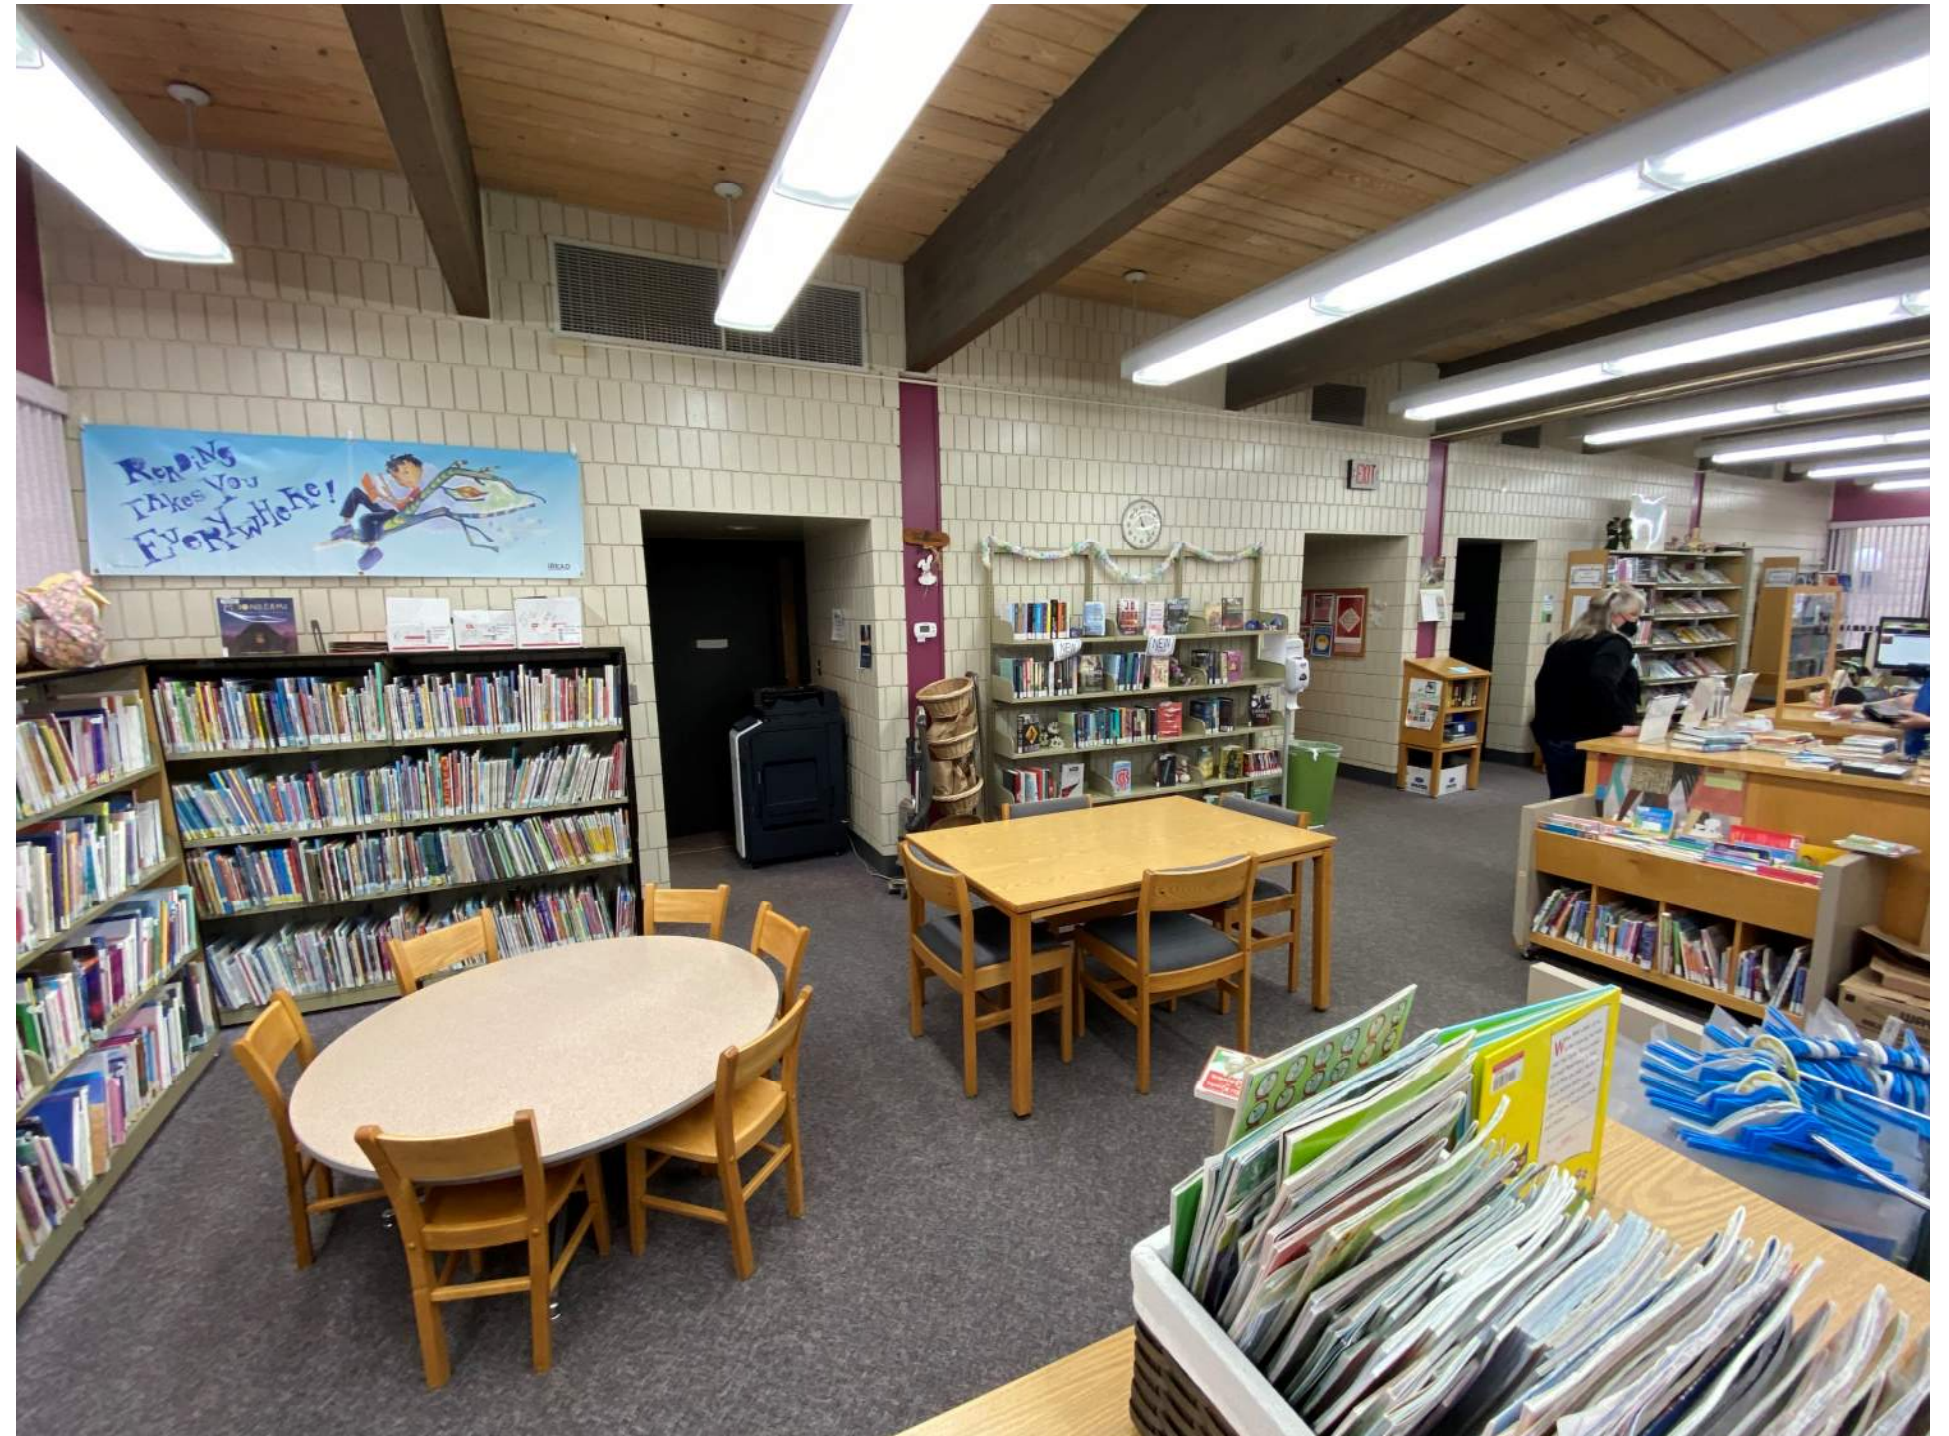
- Not enough space for kids and caregivers
- No room for increased children's collection
- No dedicated space for teens

View of children's area

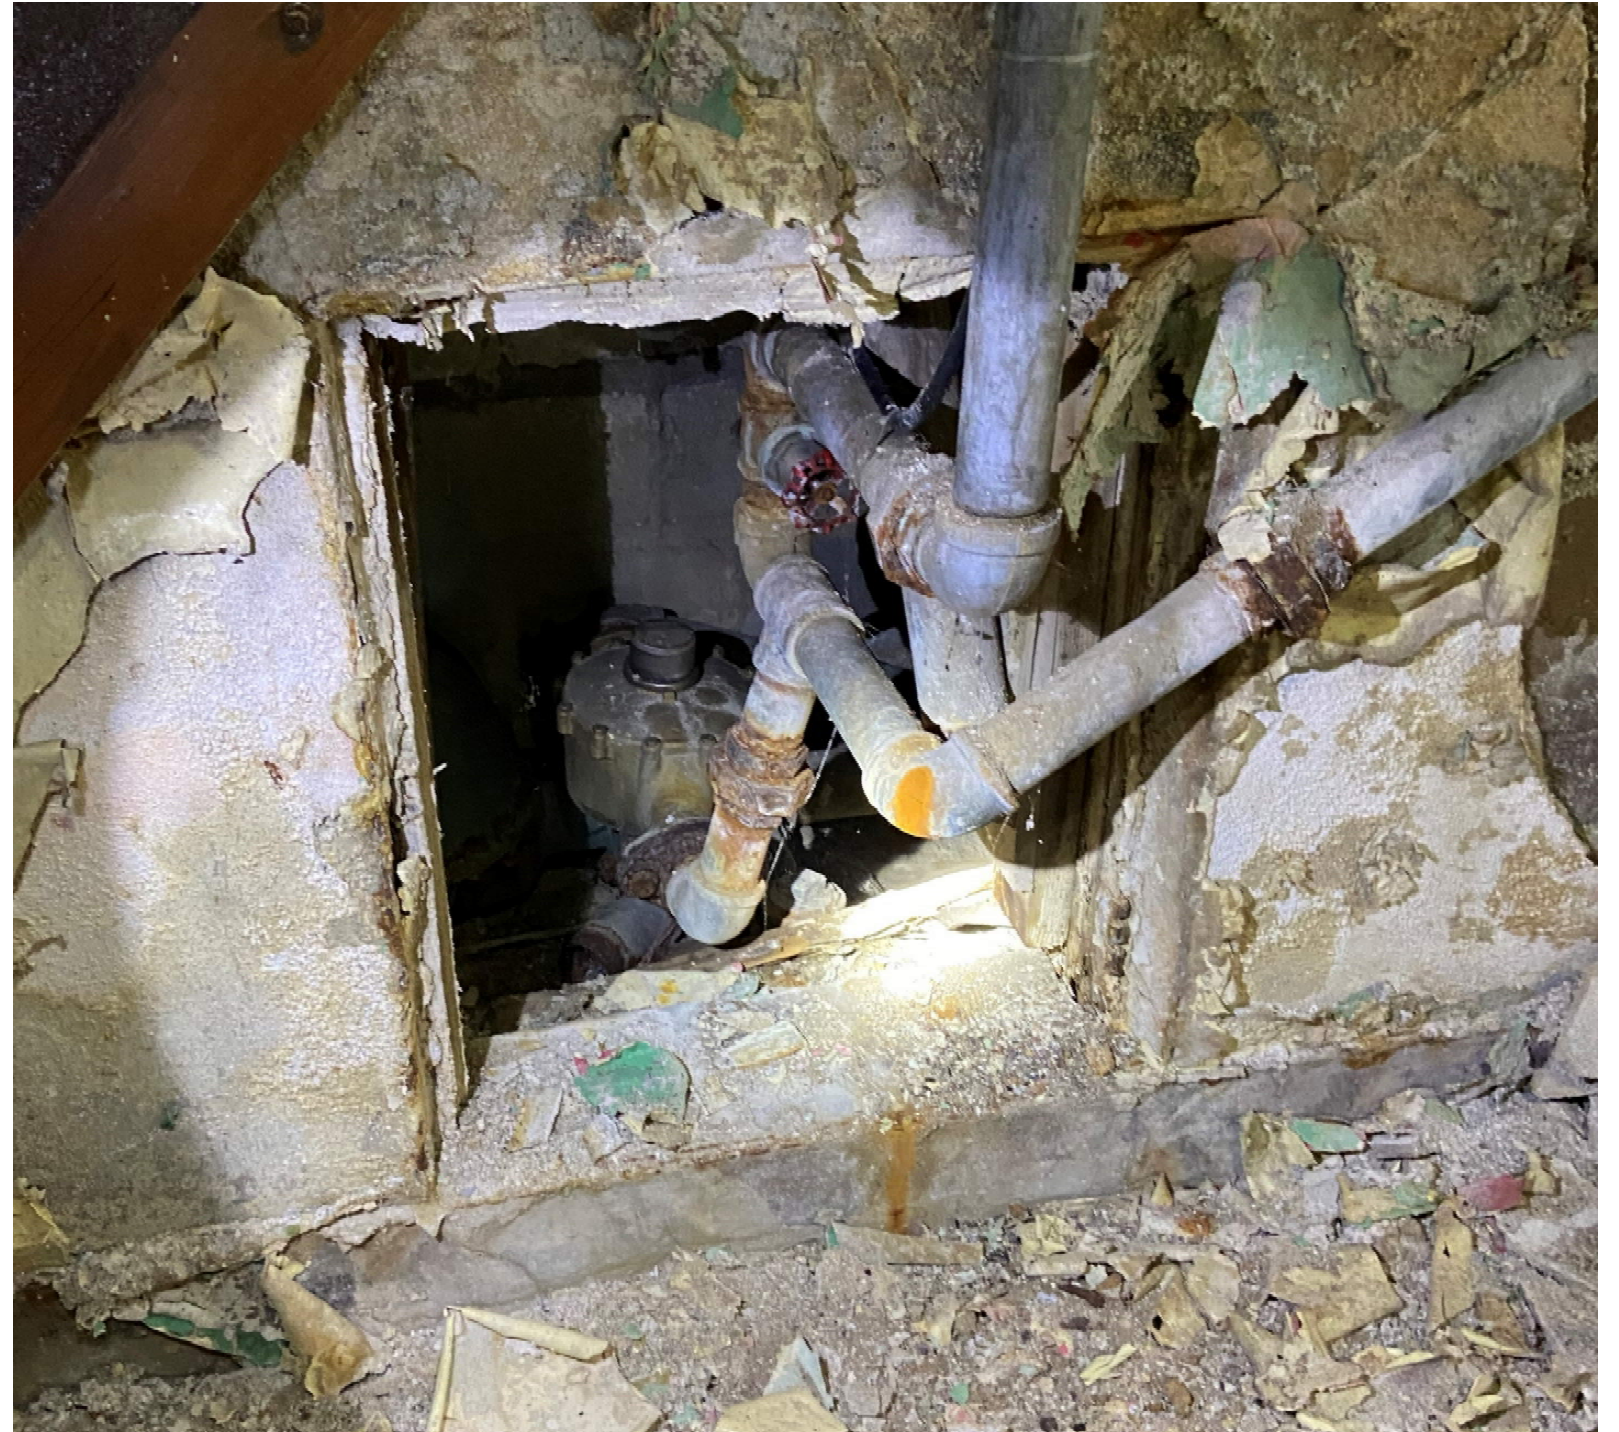
- The existing 3 inch domestic water service serves the entire facility.
- The meter and valve assembly serving the building appear to be corroded and in need of replacement.
- Recommendation
 - Remove and replace existing meter set, reconnect to the existing building water line, and provide a new dedicated domestic water line to serve the proposed library plumbing fixtures.
 - Provide new electric hot water heater to serve library sinks.
 - Extend natural gas piping to new HVAC units.

Existing water service in the basement

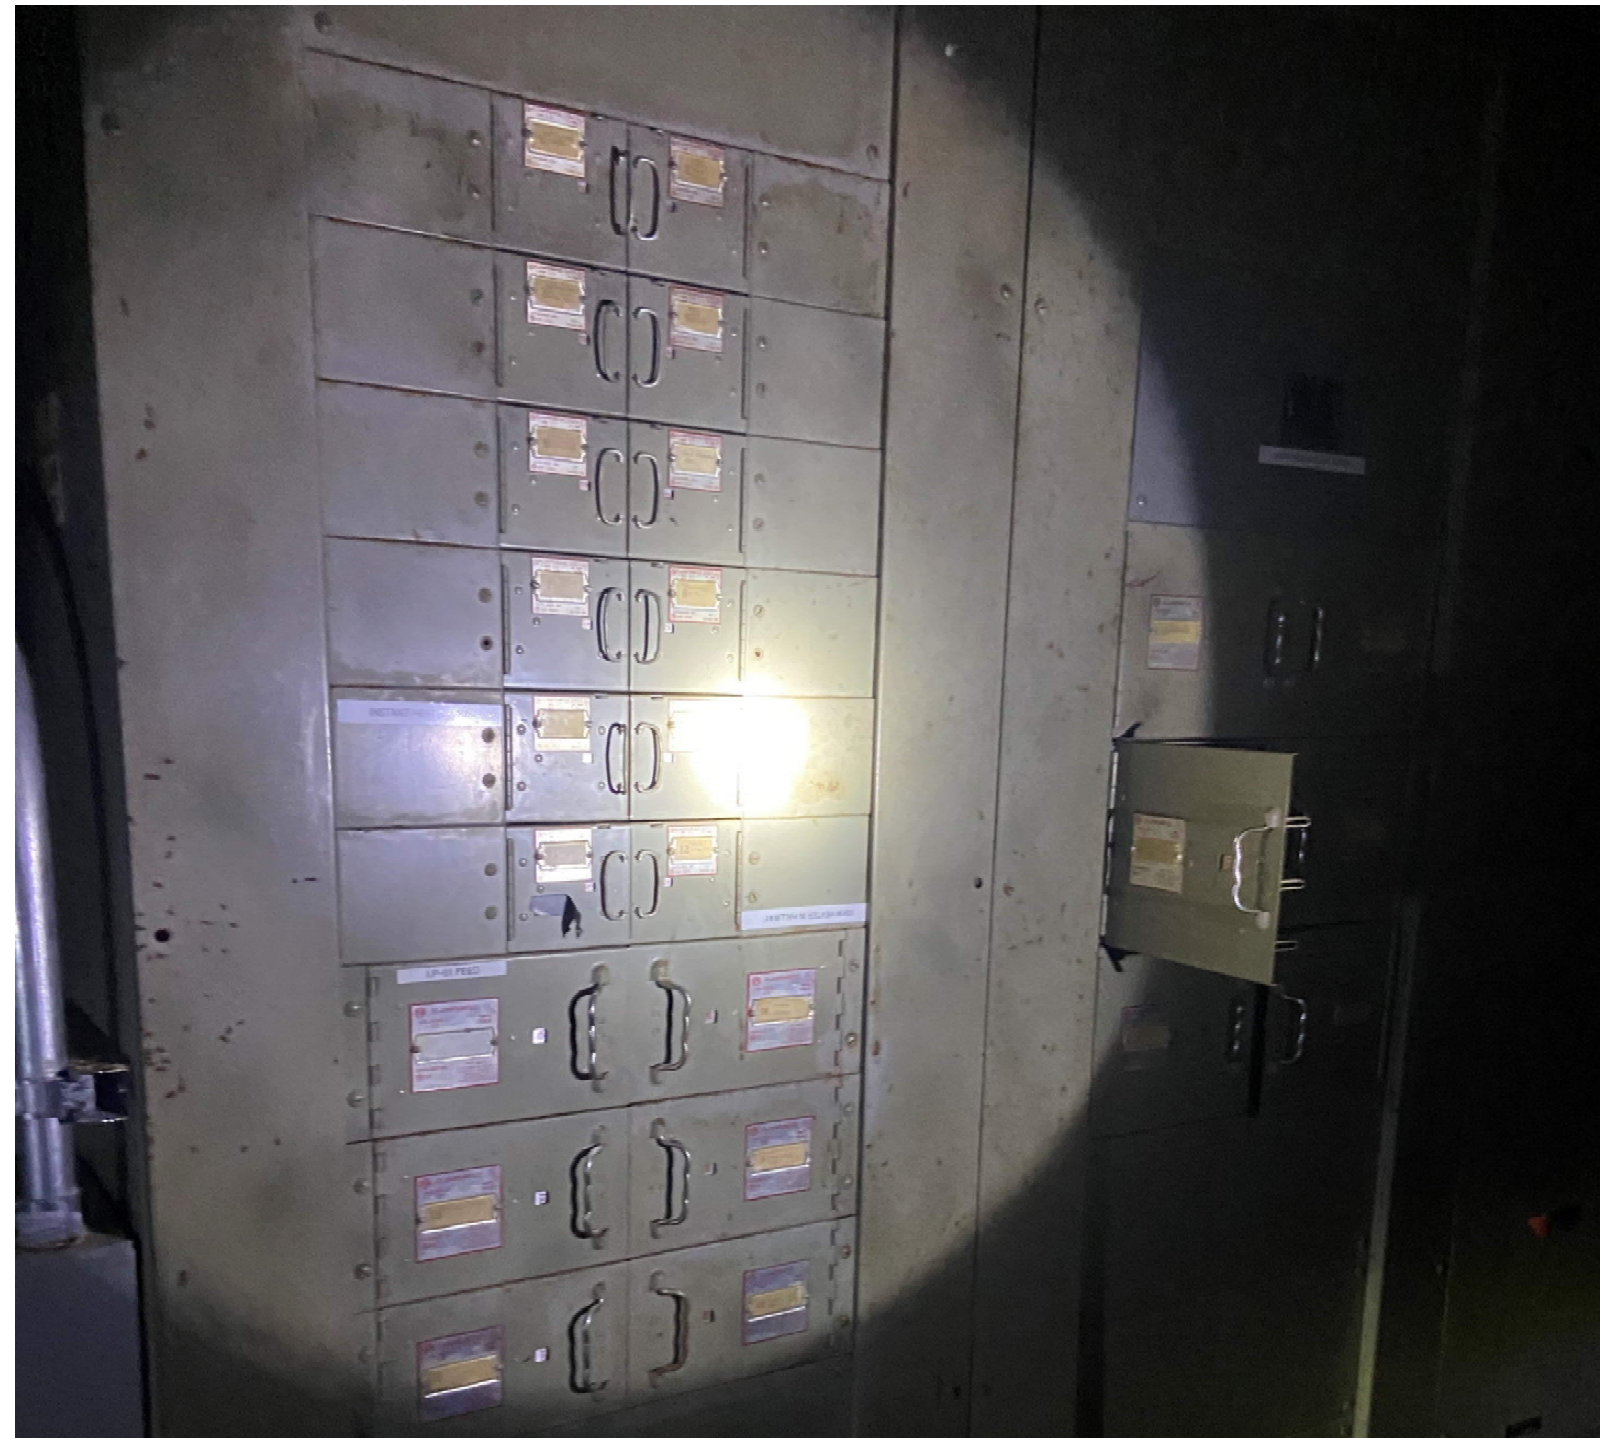
- The primary electrical service for the building was installed in 1952 and is beyond its useful life. It is not recommended for reuse.
- The existing switchgear and fused subpanels do not meet current electrical codes and should be replaced.
- The equipment is most likely not an immediate fire hazard however The Building Owner's and Managers Associated Preventative Maintenance Guidebook recommends that this type of equipment be replaced after 40 years, when kept in a dry and non-corrosive environment.
- Given the age of the equipment, a building inspector could require that the service be replaced before signing off on the electrical inspection.

Existing electrical panel in the basement

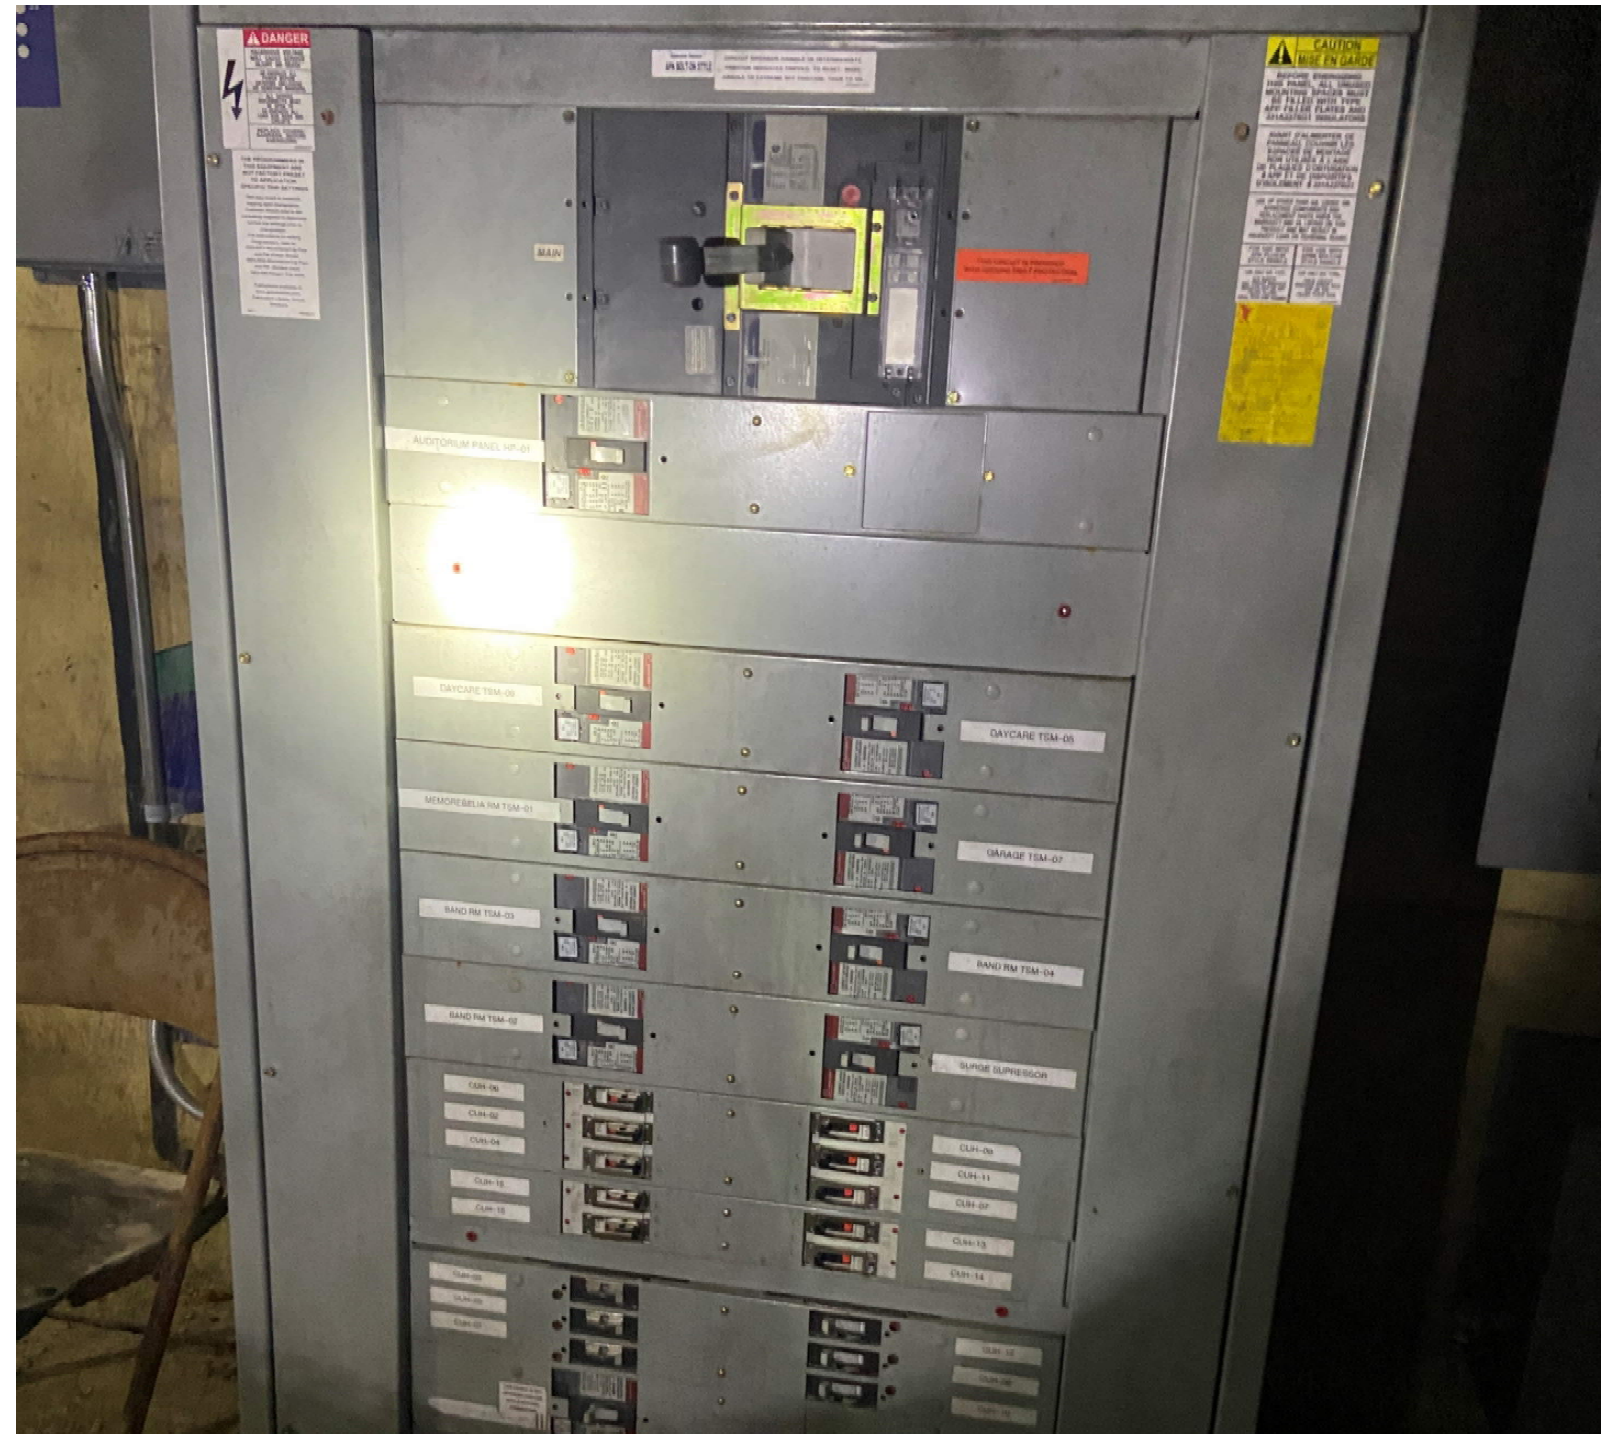
- The existing HVAC electrical panel could likely be used for library power after removal of the existing cabinet unit heaters. However, this service is off-peak service only. To be used for the library this would need to be switched to standard service, not off-peak.
- Recommendation
 - Install new electrical service, switchgear, and subpanels for library.
 - Replace all existing lighting to LED.
 - Update receptacles for power and data.
 - If new service is not added as part of this project, the building inspector should be consulted beforehand to ensure that replacement will not be required.

Existing HVAC electrical panel in the basement

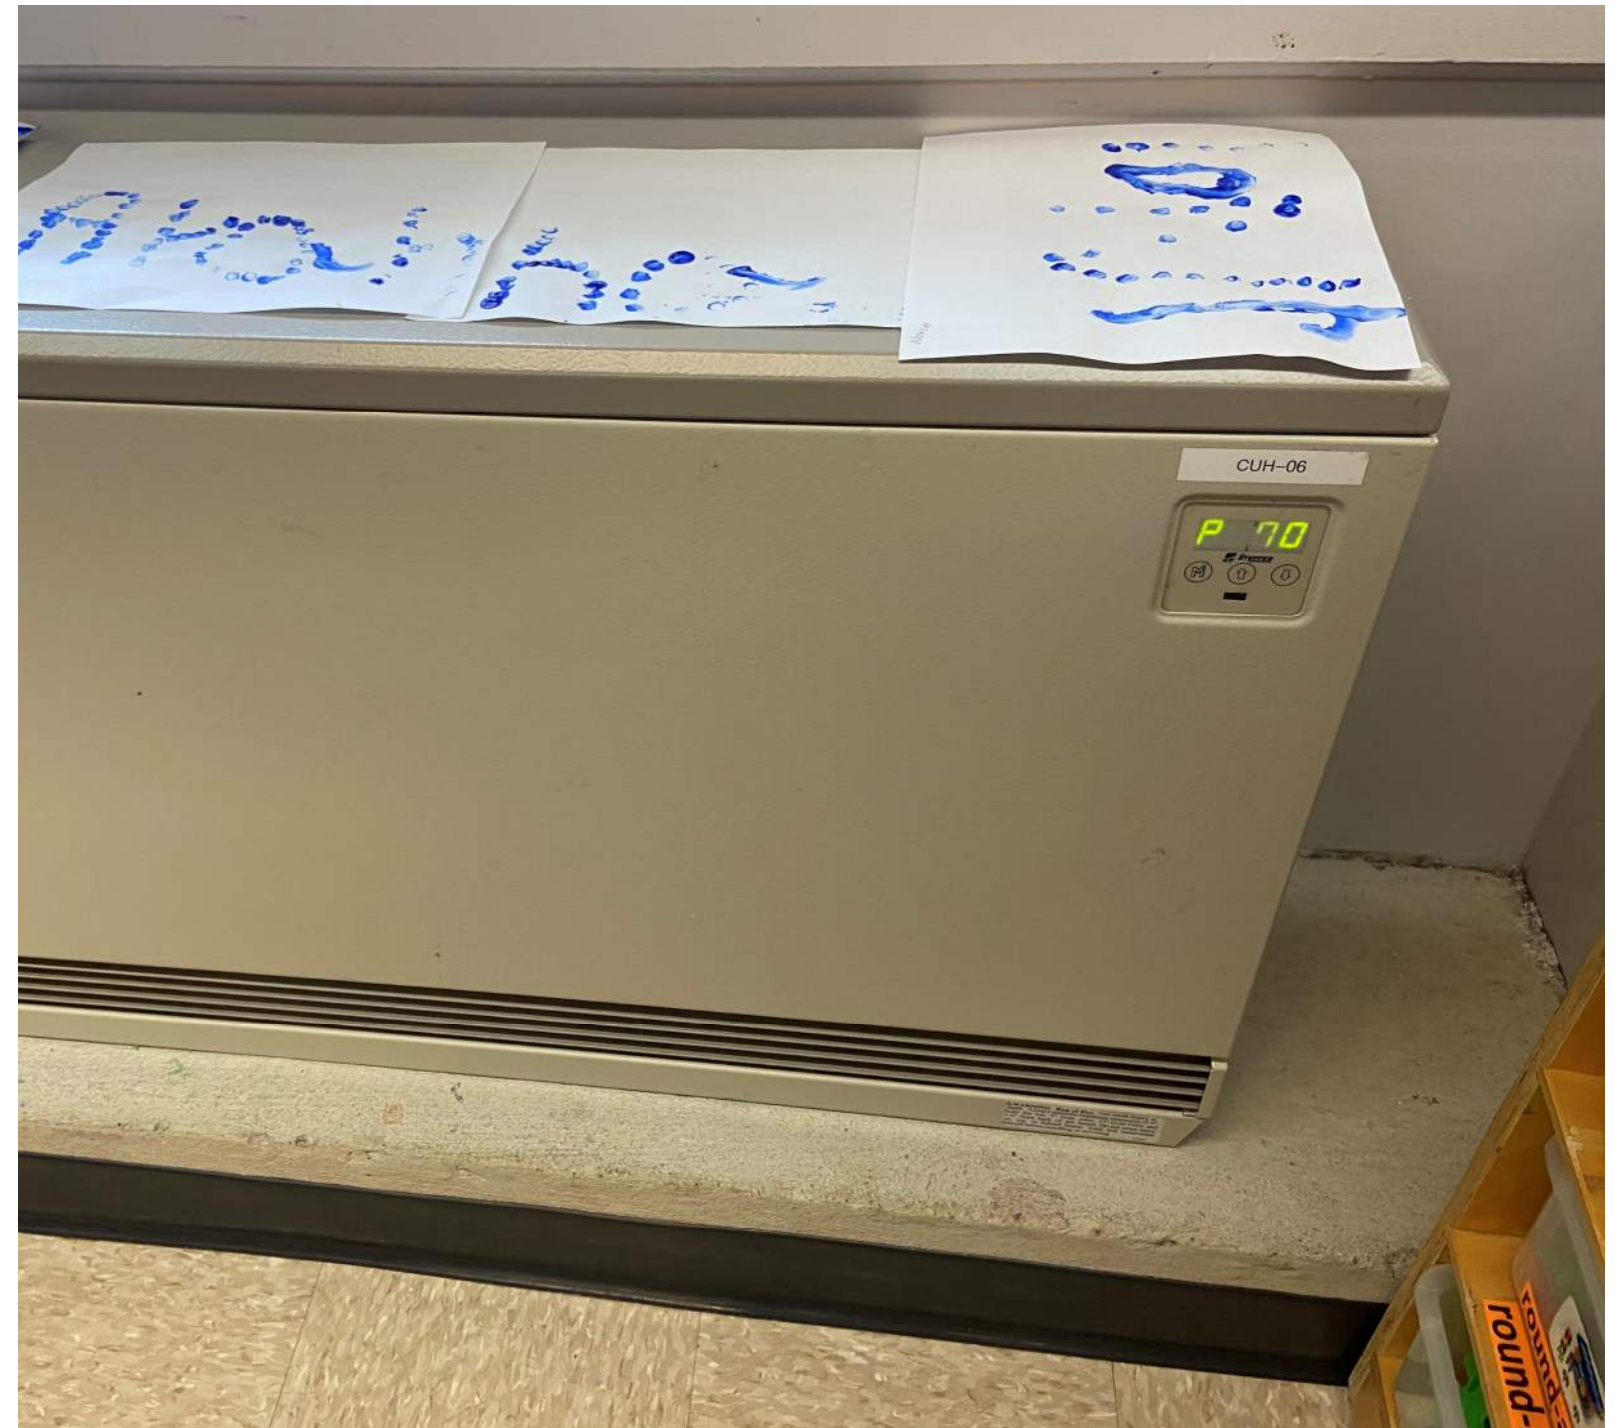
- It is not clear that there is an active ventilation system in the building. This system is required by code and will need to be added.
- Existing cabinet unit heaters provide heating, but not cooling.
- The only air conditioning in the building is within the daycare space.
- The controls system is outdated, the manufacturer is no longer in business to provide service or replacement parts.
- Units take up significant amount of floor space and will affect furniture and shelving layouts.
- Recommendation
 - Install a new packaged HVAC unit on the roof that will provide heating, cooling, and ventilation for the library space. (15 – 17.5 ton unit is anticipated.)

Existing cabinet unit heater in classroom

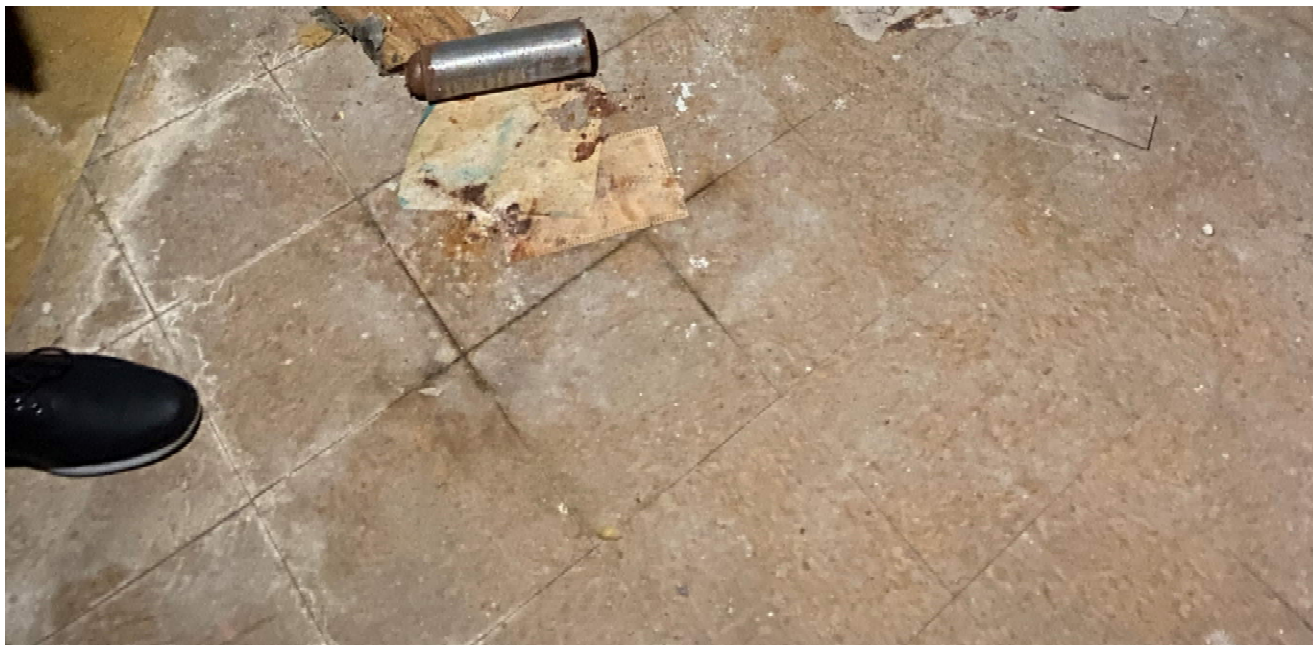
- There are a handful of building materials that may contain asbestos
 - Floor tiles
 - Pipe insulation
 - Ceiling adhesive
- A hazardous materials survey should be completed to understand the scope of the abatement for the project.

Potential asbestos floor tile

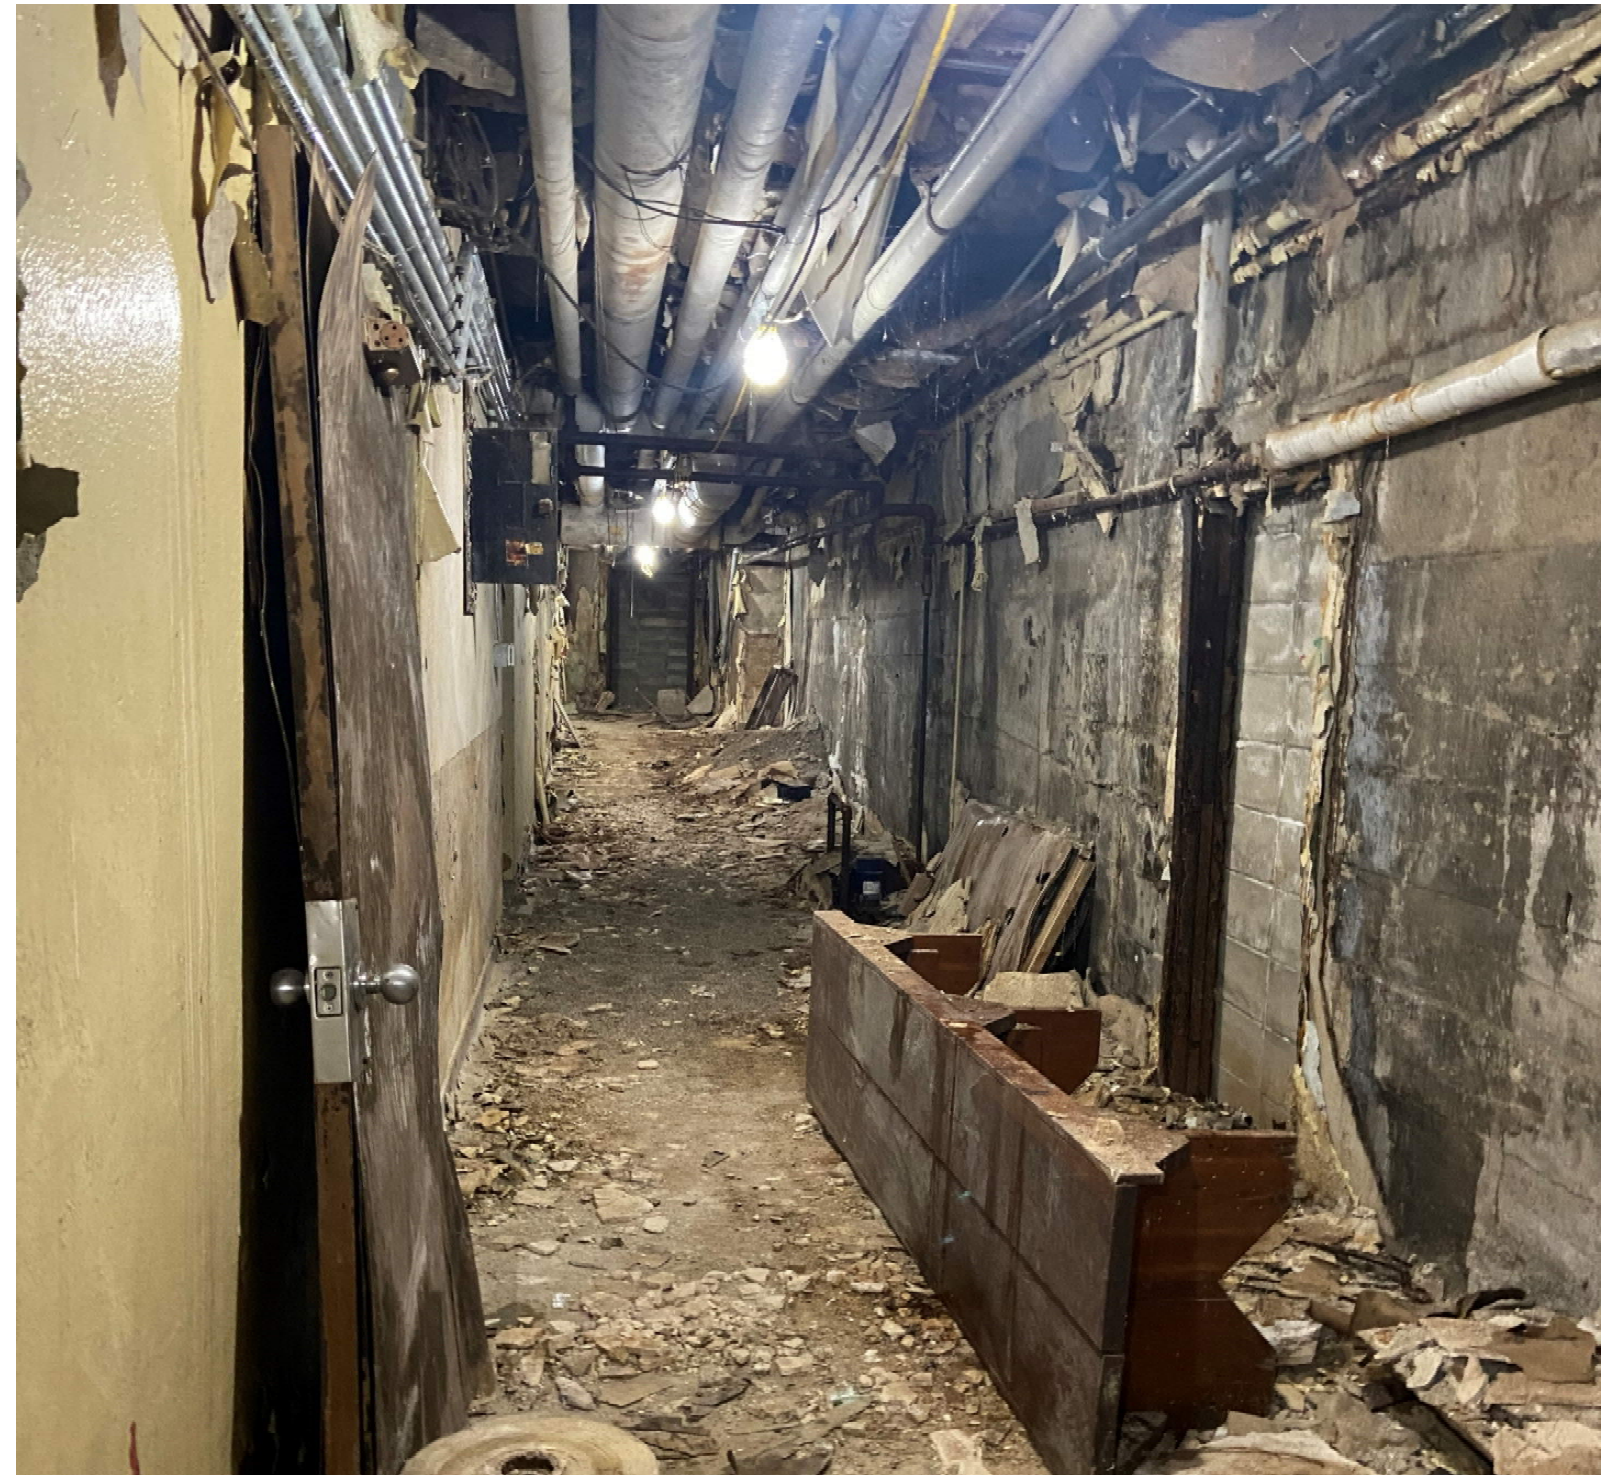
Potential asbestos pipe insulation and lead paint

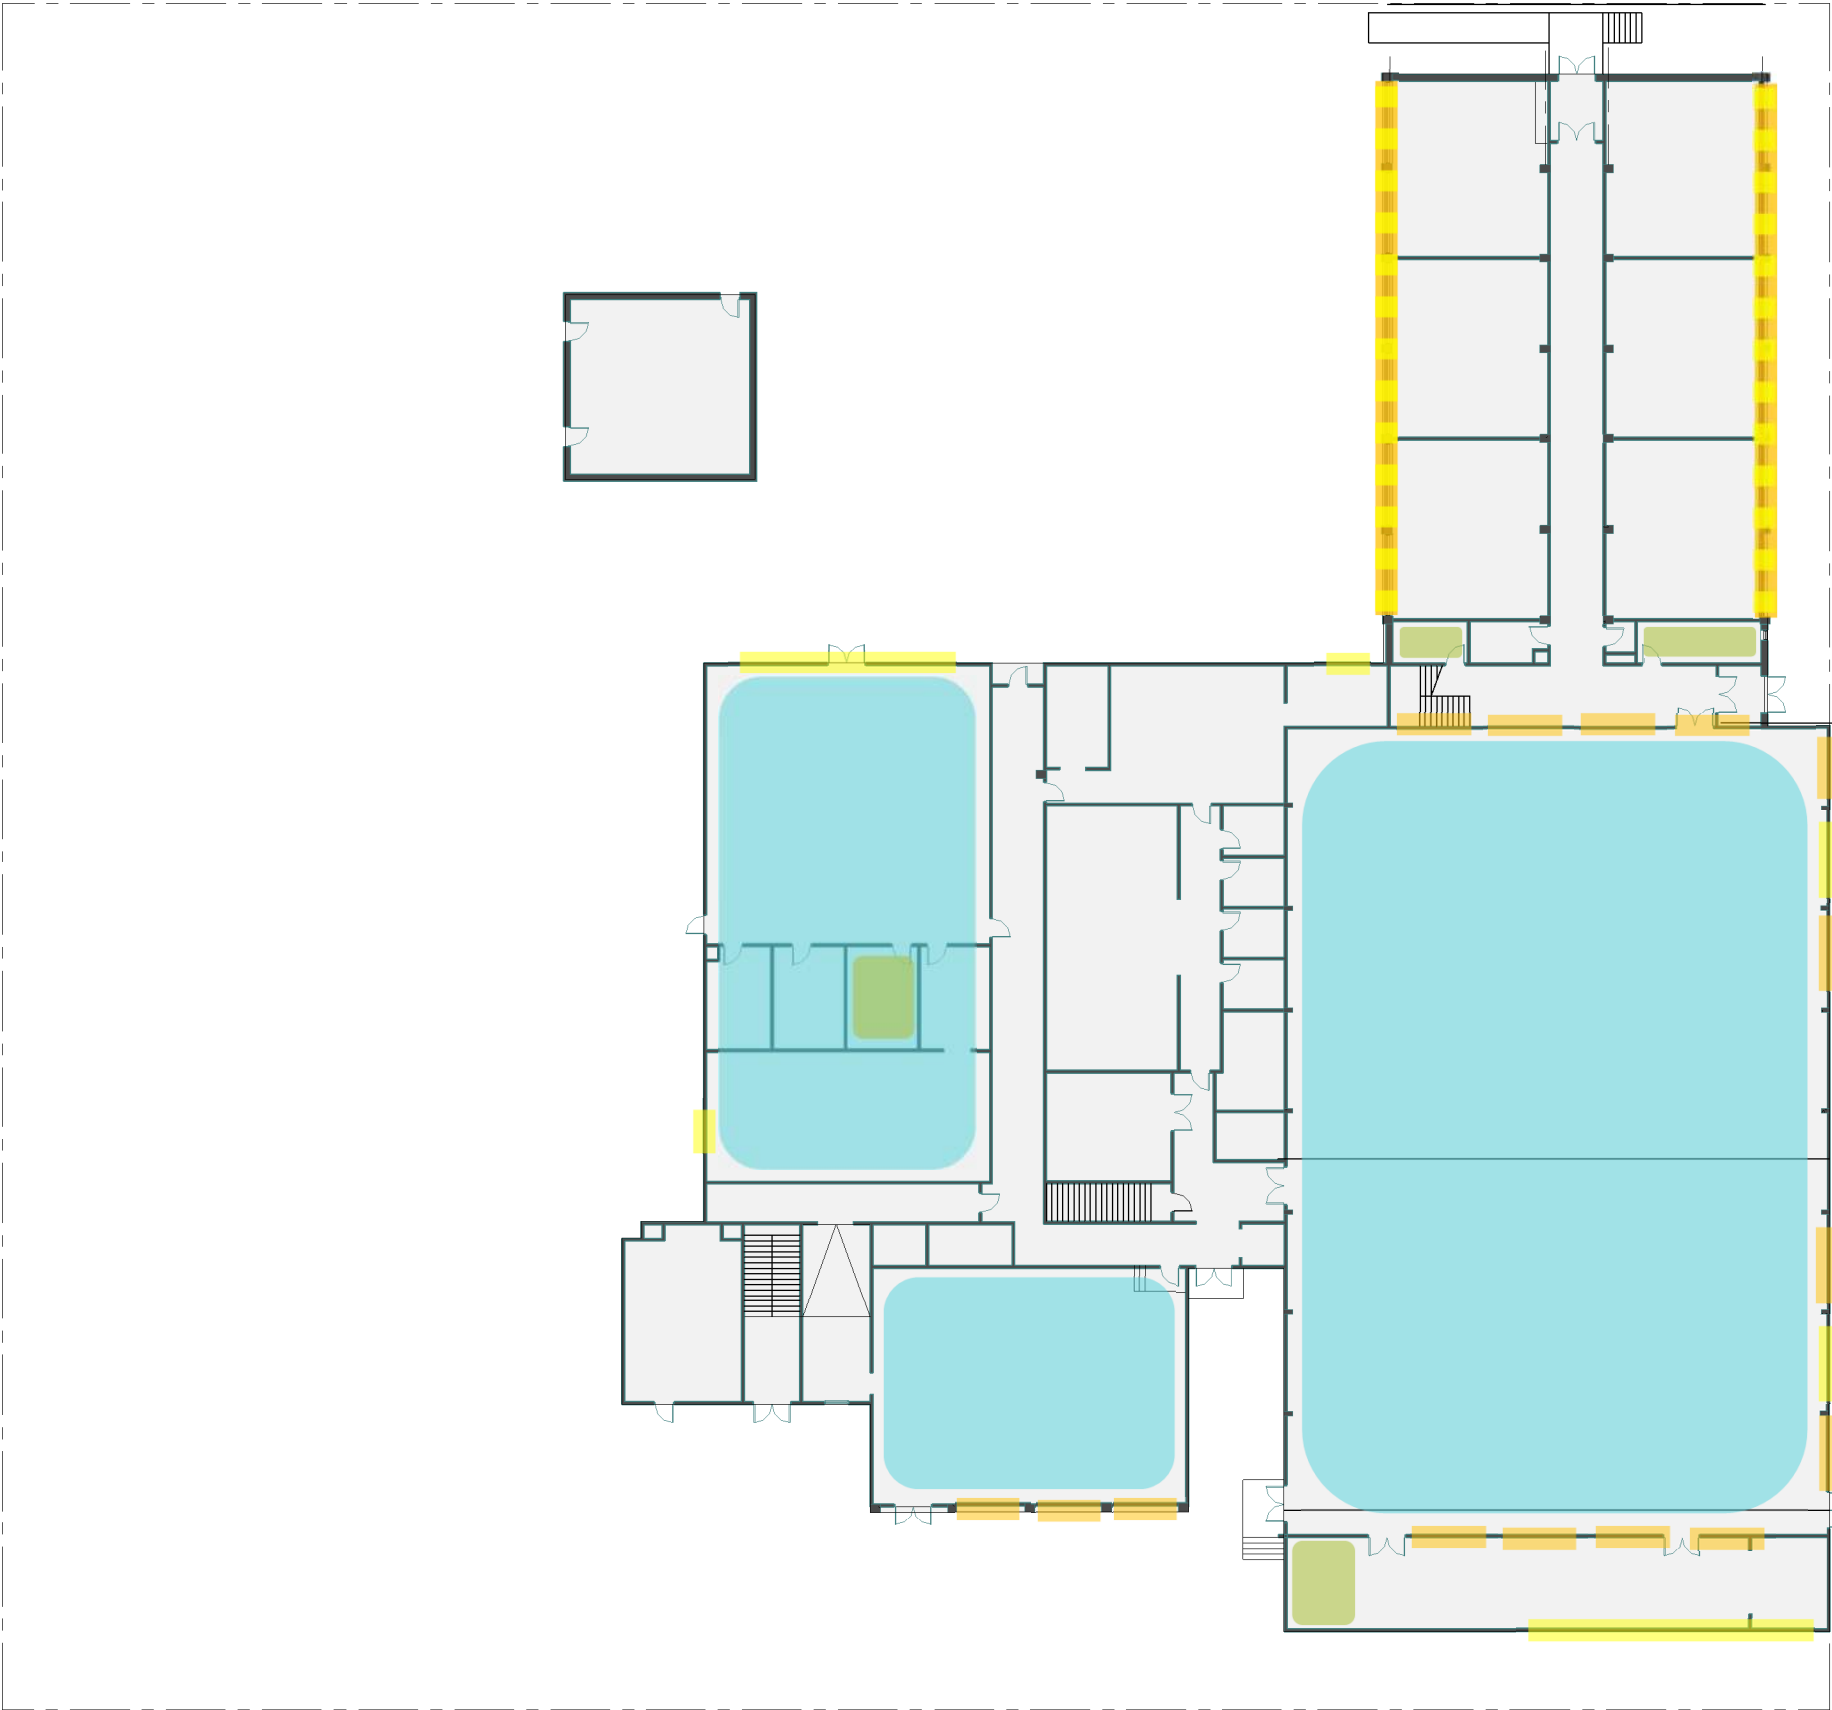
- Windows
- Openings that have been infilled and can be reglazed
- Spaces with tall ceilings and few interior columns (ideal for rooms > 50 people)
- Existing bathrooms
